TECHNICAL INFORMATION

Lambretta

Report No.:	TIN_2018_LB_1_6	Done by:	Schorm
Model:	V50, V125, V200	Approved by:	Groll
VIN No.:	VDL ***** JS*****		
Page 1 / 1	SAFETY INFORMATION FRONT TIRE

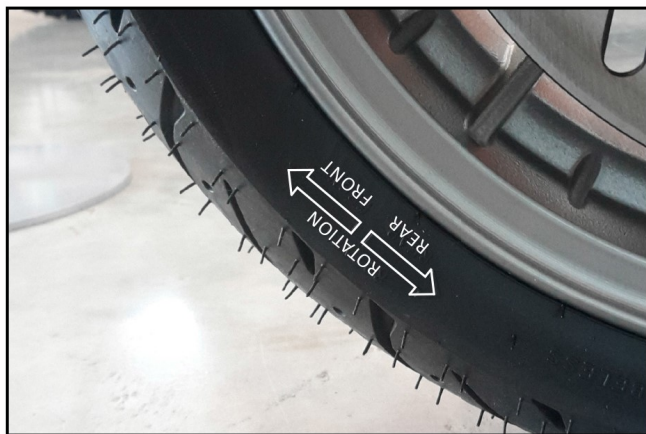
Direcção errada / Wrong direction

Occasionally it could occur, that on the V-series, the direction of rotation of the Pirelli tire on the front rim (Type: Pirelli Angel Scooter) is reversed. Use the indicator on the sidewall of the tire to check whether the direction of rotation is right. (refer to pictures below)
This does not represent a safety problem, but should be corrected before delivery to the customer or at the next customer service.

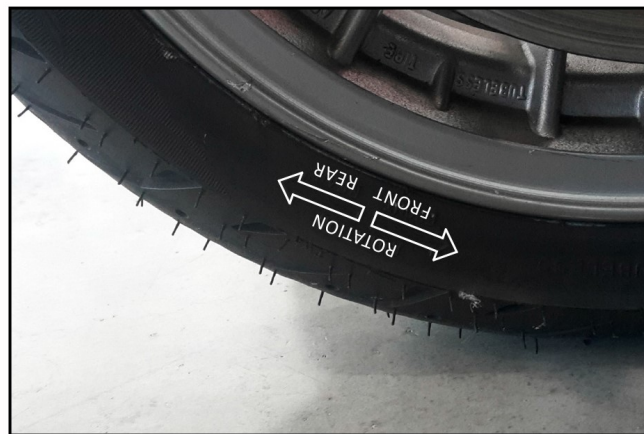
Direcção correcta / Right direction:
